Manhole Inspection Summary

Manhole # S23GG1002MH

Location Address: **1407 Redfern Ave**

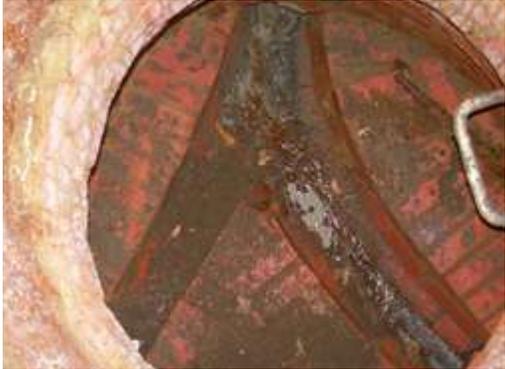
Top View

Bench and channel debris

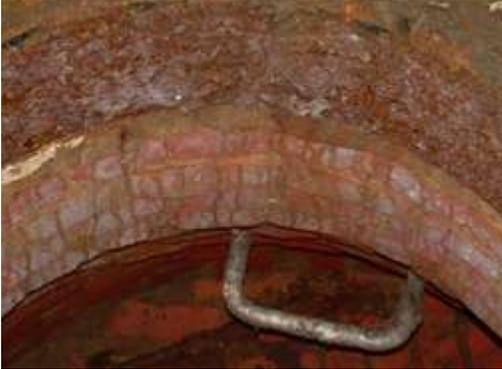
Defect

Frame Offset: **1** (in.) Condition: Sound Cracked **Leaks**

Infiltration: None **Joint** Cracks Mortar Roots Wall

Frame leak, adjustment infiltration

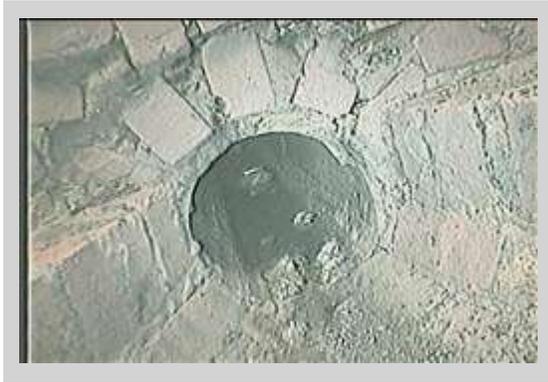
8 in. Circular Gravity Sewer
Pipe Out @ 12 O'Clock

Pipe Material: **Clay** Pipe Lined

Invert Depth: **4.93** (ft.) Flow Characteristics: **None**

Deposits: None Mud Sludge **Debris** Grease

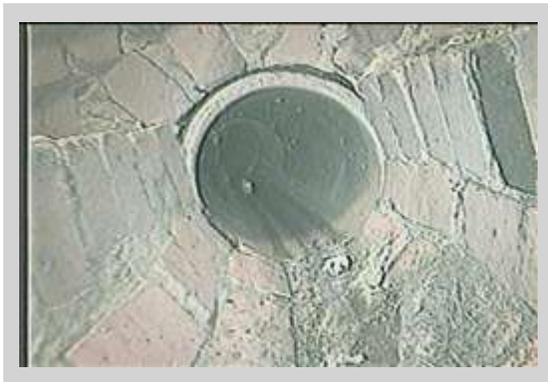
8 in. Circular Gravity Sewer
Pipe In @ 4 O'Clock

Pipe Material: **Clay** Pipe Lined

Invert Depth: **4.79** (ft.) Flow Characteristics: **None**

Deposits: None Mud Sludge **Debris** Grease

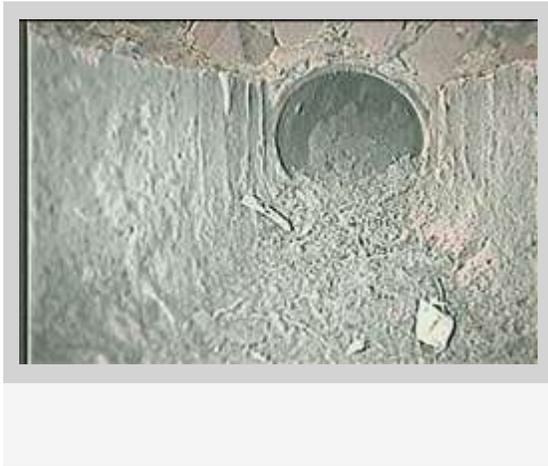
6 in. Circular Gravity Sewer

Deposits: None Mud Sludge **Debris** Grease

Silt Depth: **2** (in.) Deposits Extent: **Medium**

Connects To: **Stub connection / abandoned**
